Town of Goderich

Type of Document: Airport Pavement Condition Evaluation

Project Location: Goderich Regional Airport 33874 Airport Road Goderich, Ontario N7A 3Y2

Project Number: BAR-23008990-A0

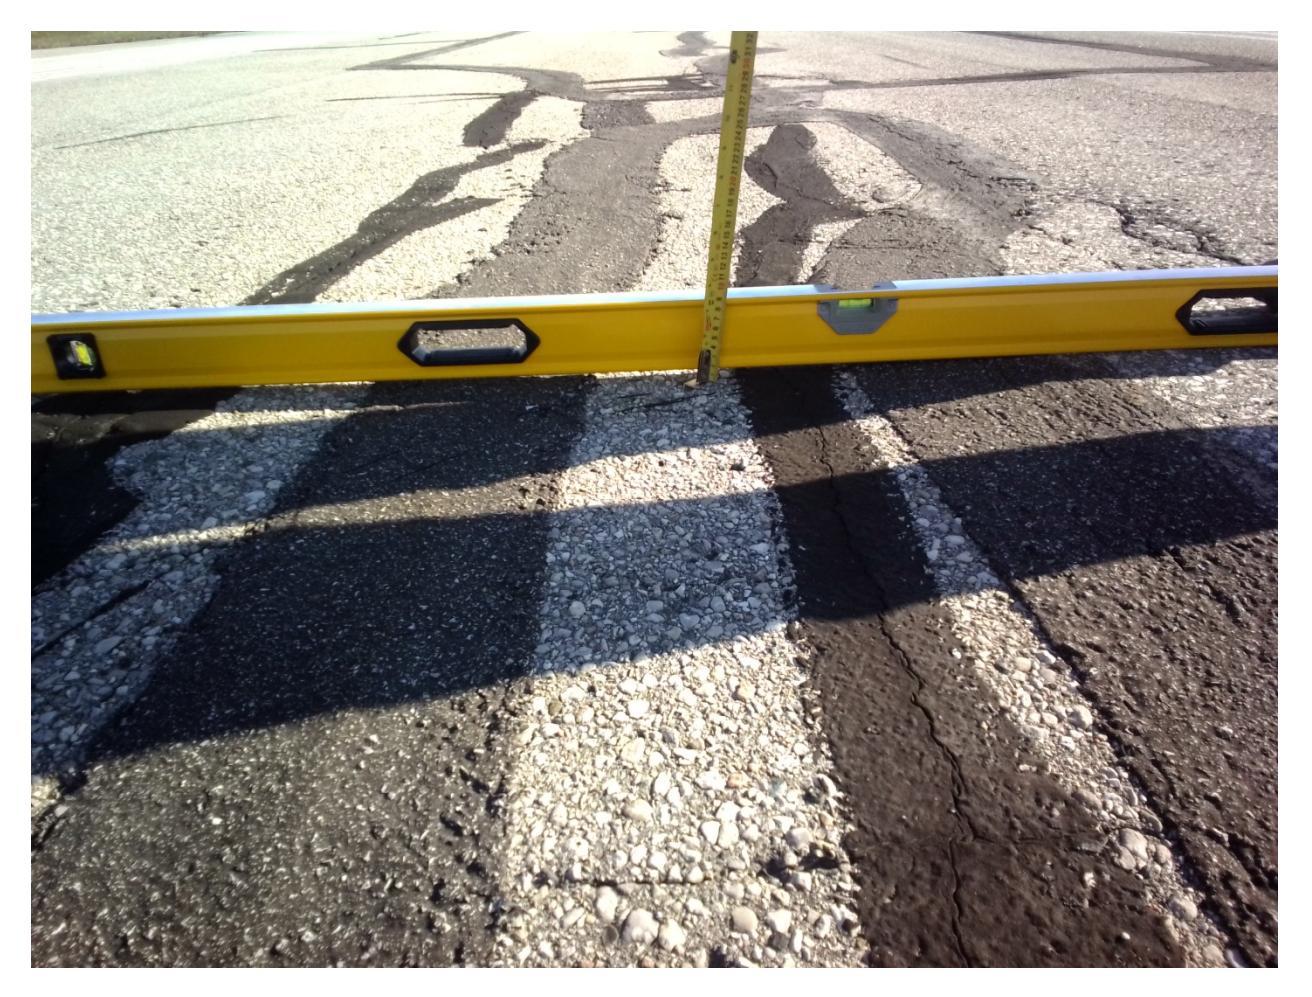
Medium severity rutting (20 to 40 mm depth) was also noted at less that 2% of the wheel path length. All noted defects were recorded on the Defect Recording Form included in Appendix A. The overall structural condition rating (SCR) is 6.9, which is fair to good.

20mm Rut and Map cracking – Runway 14-32.

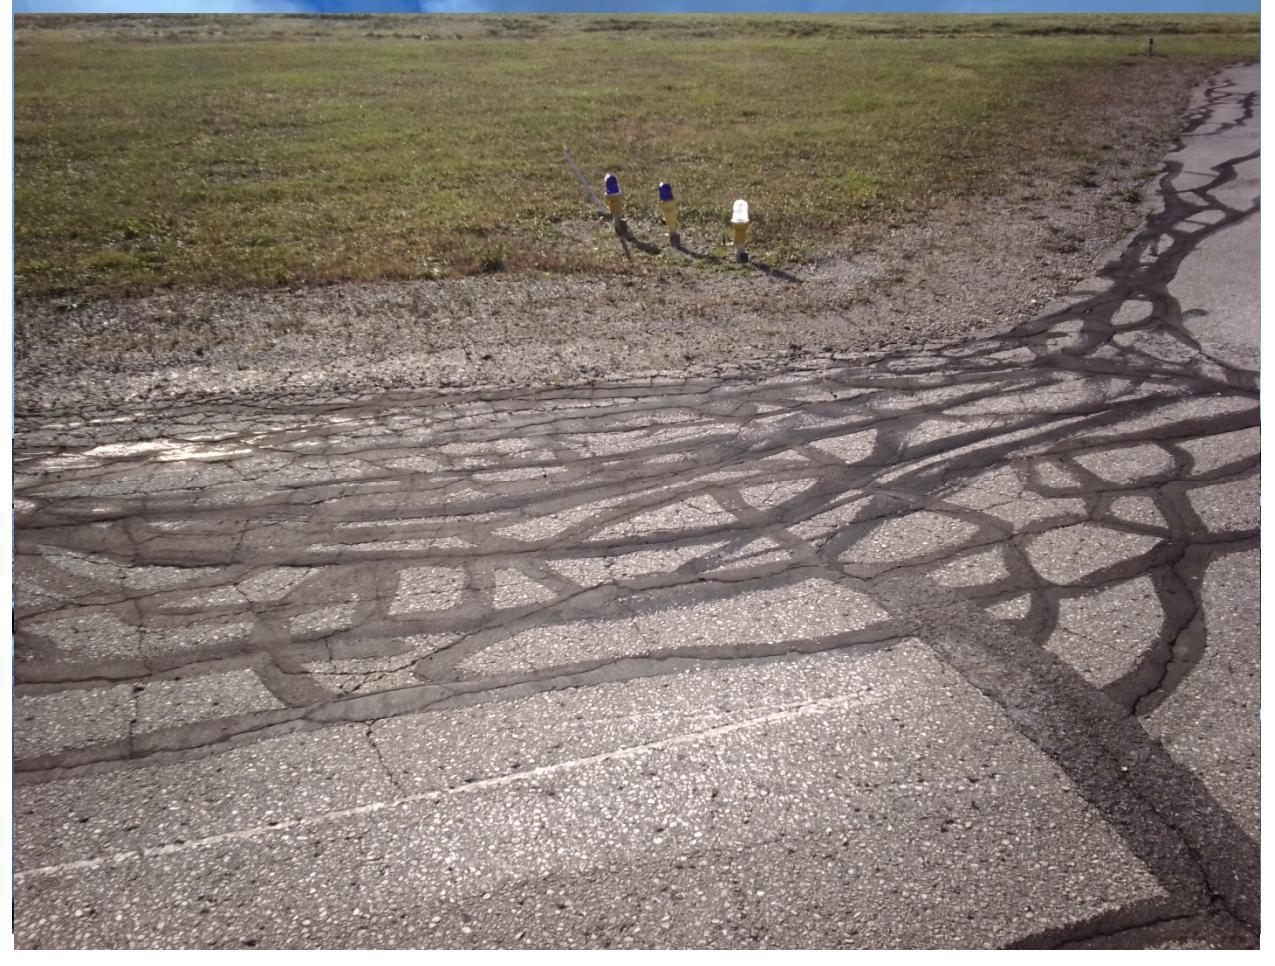
Map and Edge cracking – Runway 14-32 turnaround – North end

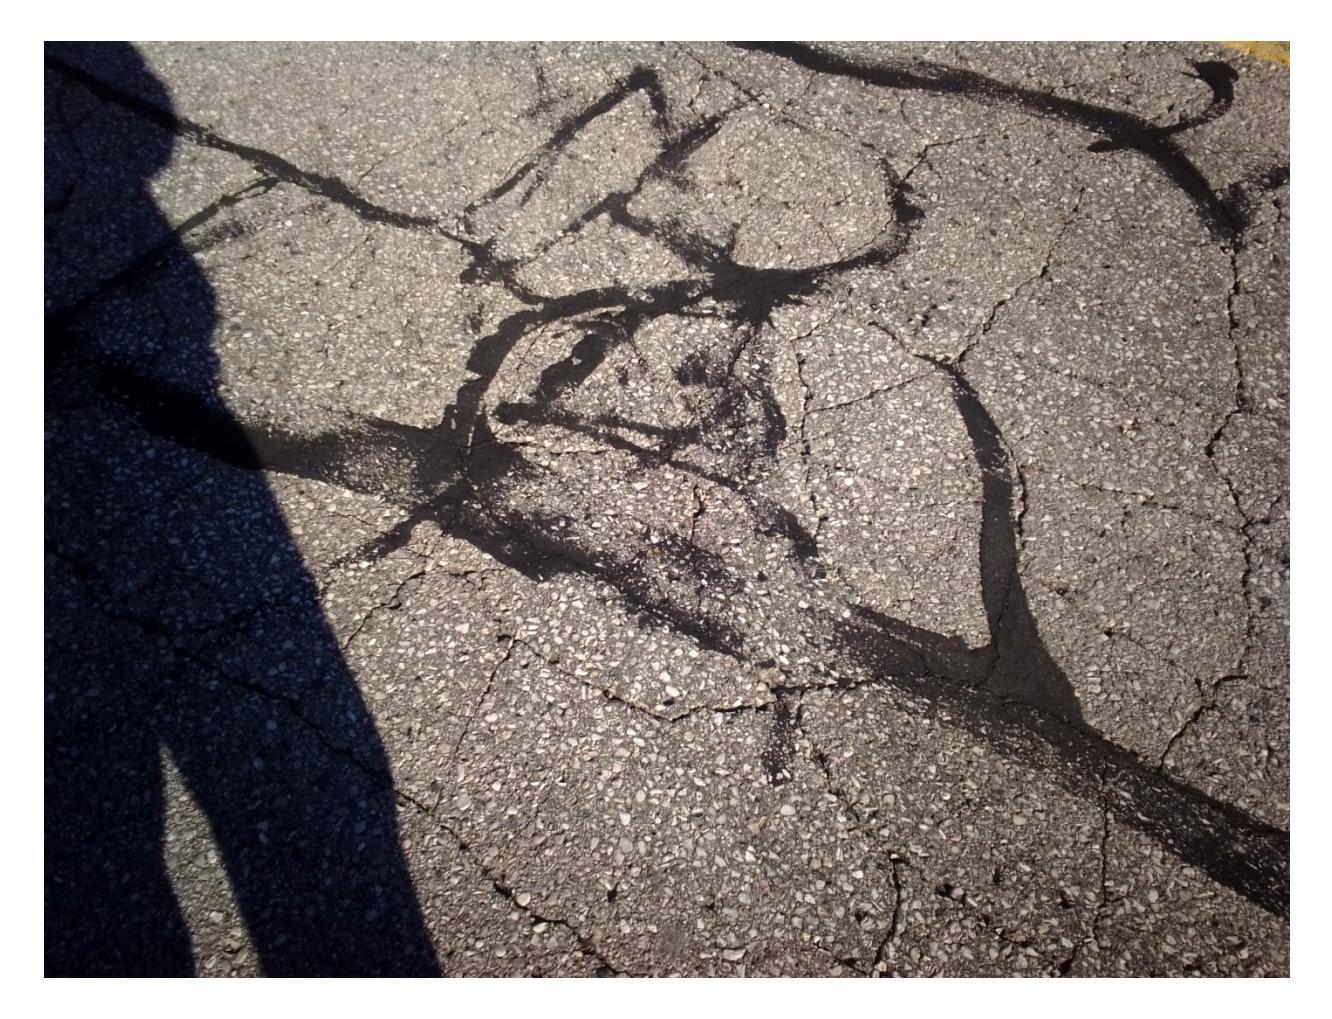
The "old" taxiway starts at the apron area, crosses Runway 10-28 and continues to approximately 45 metres north of Runway 10-28. Constructed in 1965 (same time as Runway 10-28), it is poor to fair condition with medium severity map cracking and associated rutting and low severity raveling.

Map Cracking – Old Taxiway

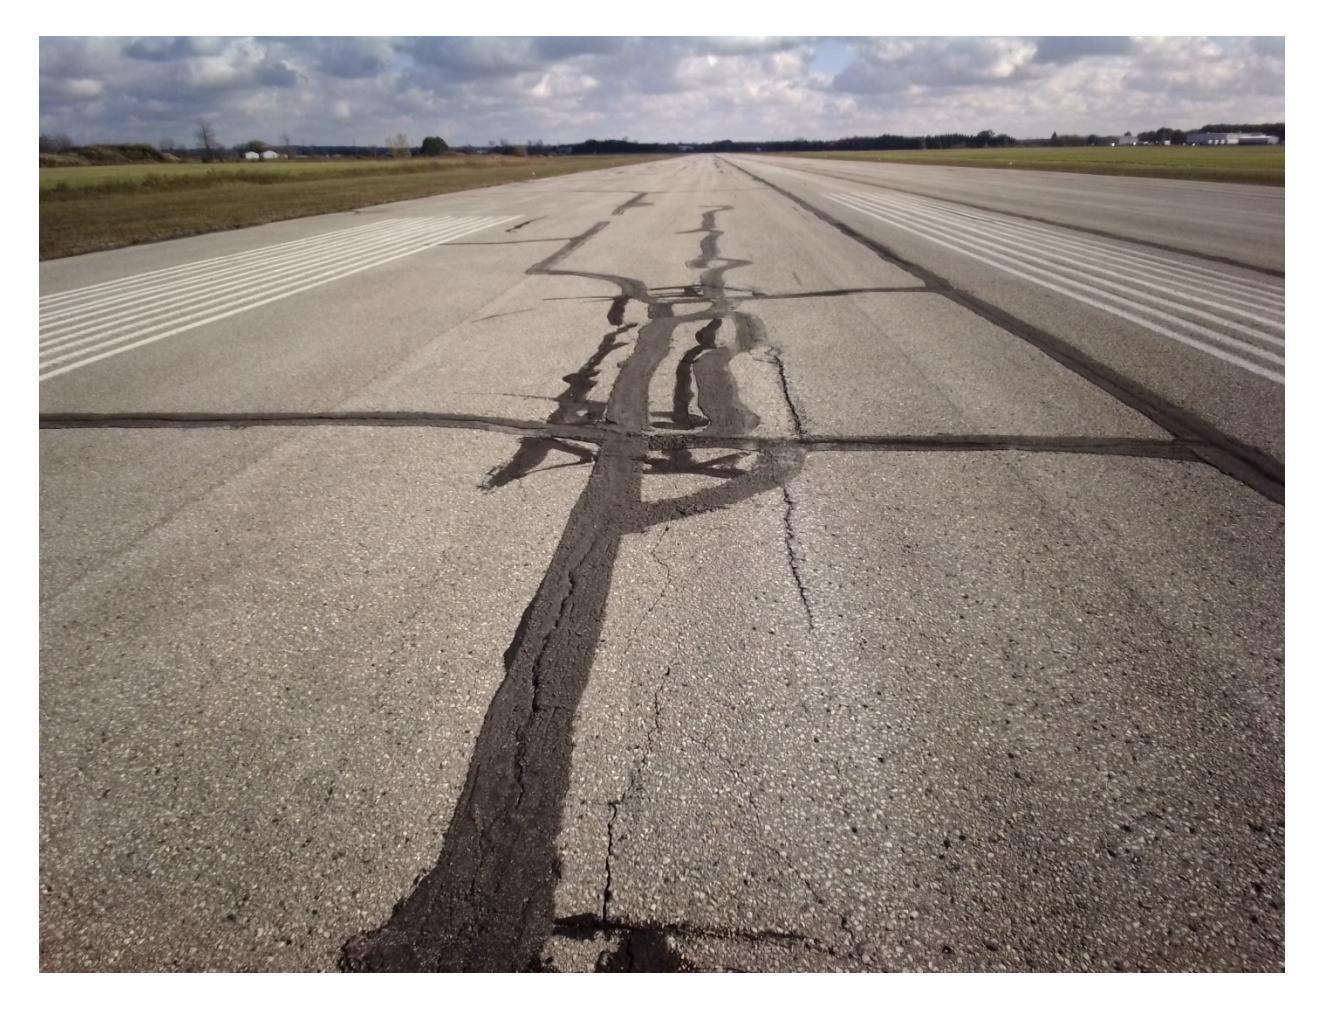
The main runway was constructed in 1990 and consists of seven "lanes" of asphalt along the main portion of the runway with wider turn-around areas at each end. The most prevalent defect observed along the length of the runway is lateral and transverse cracking. According to the Town of Goderich, this runway received an application of crack sealing in 2018. Based on the visual appearance of the crack sealing materials, there may have been additional applications as the colour of the sealant varies. The existing crack sealing is starting to fail (open cracks in the sealant are visible within the asphalt cracks) and a new application is required. Additionally, the turn-around area that is shared by both runways appears to have only been partially treated in the past.

Transvers and Lateral cracking with small Map cracking area Runway 14-32

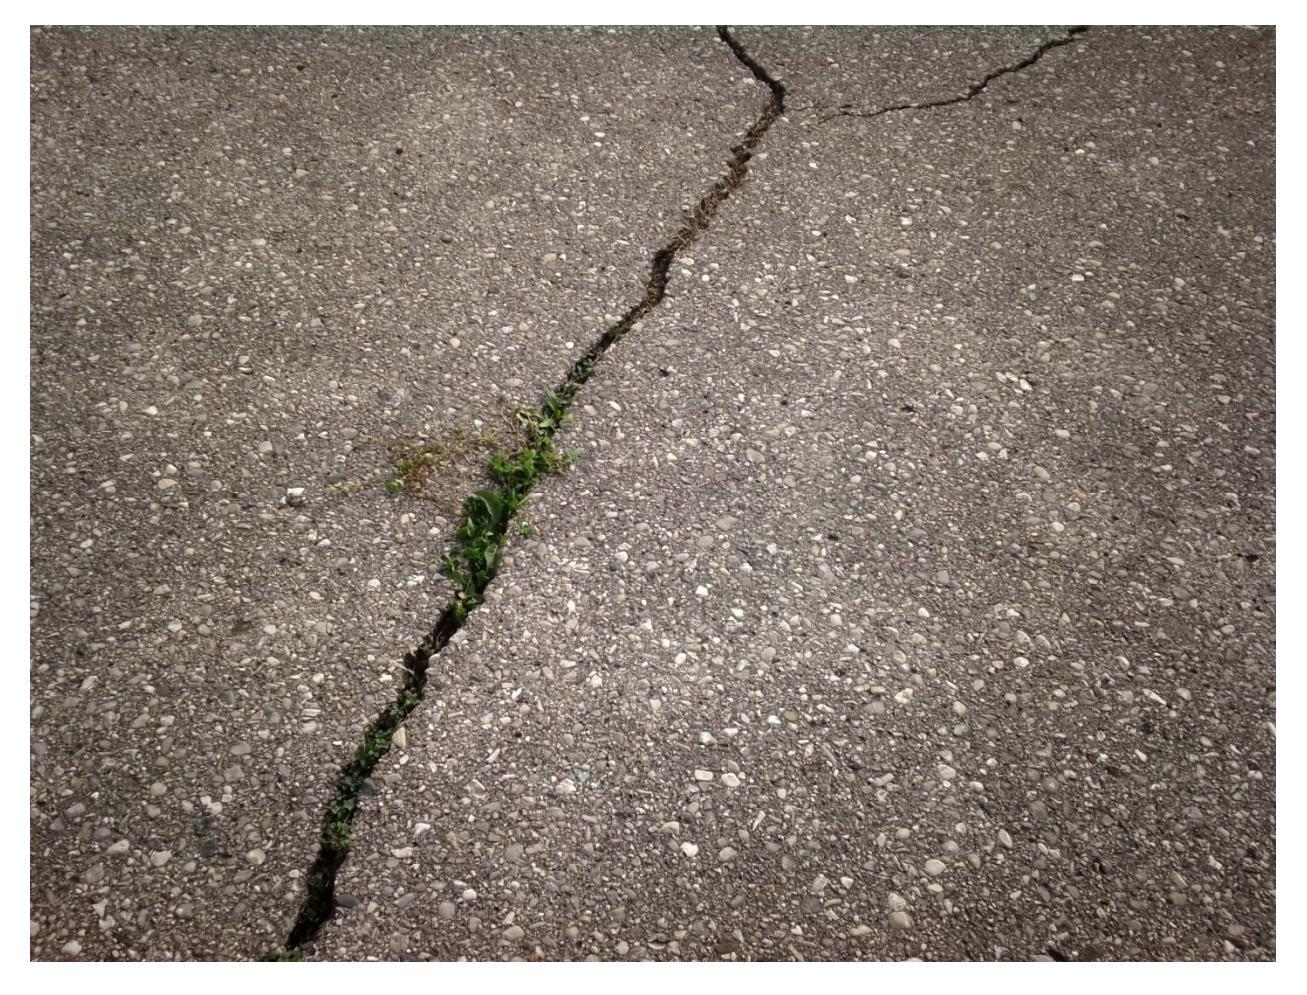
Unsealed Cracks – Common Turnaround

Overall, the paved surfaces of the runways and taxiways at the Goderich Municipal Airport are in fair to good condition. It is recommended that crack sealing be maintains on a regular basis to prolong the lifespan of the pavements. Based on discussions with airport staff, the traffic at the airport averages between approximately 2 500 and 3 000 aircraft movements per year, with the busiest times in the summer months (June, July and August). This traffic pattern has held fairly steady since at least 2014. Given the generally unchanging conditions and lack of any significant commercial traffic, the condition of the runways is relatively consistent.
