GODERICH COAST SHORELINE EROSION

FEASIBILITY STUDY

TOWN OF GODERICH
GODERICH COAST SHORELINE EROSION
FEASIBILITY STUDY

September 25, 2024

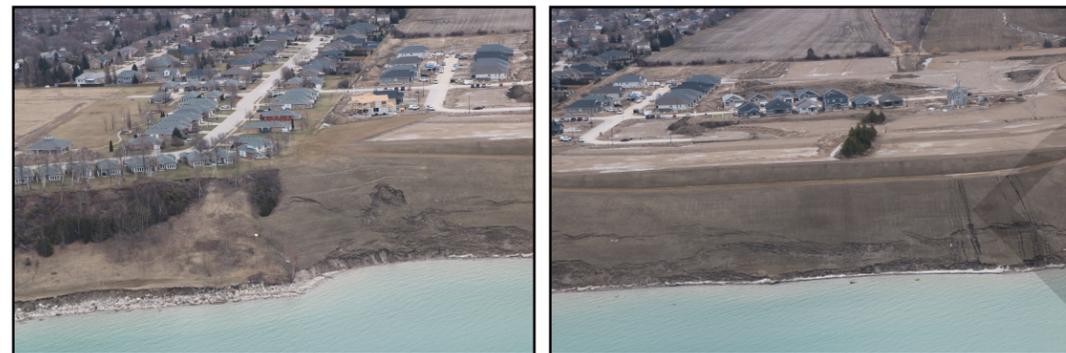
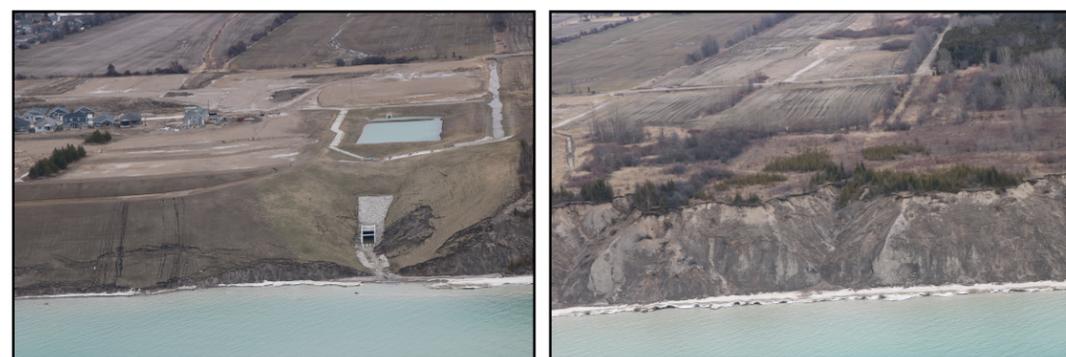
SITE PHOTOS TAKEN ON APRIL 20, 2022

1. NORTH EXTENT AT BEGINNING OF COAST DEVELOPMENT

2. SHORELINE AT COAST DEVELOPMENT

3. COAST DEVELOPMENT SWM FACILITY AND OUTLET TO LAKE

4. SOUTH EXTENT AT DECHERT ROAD

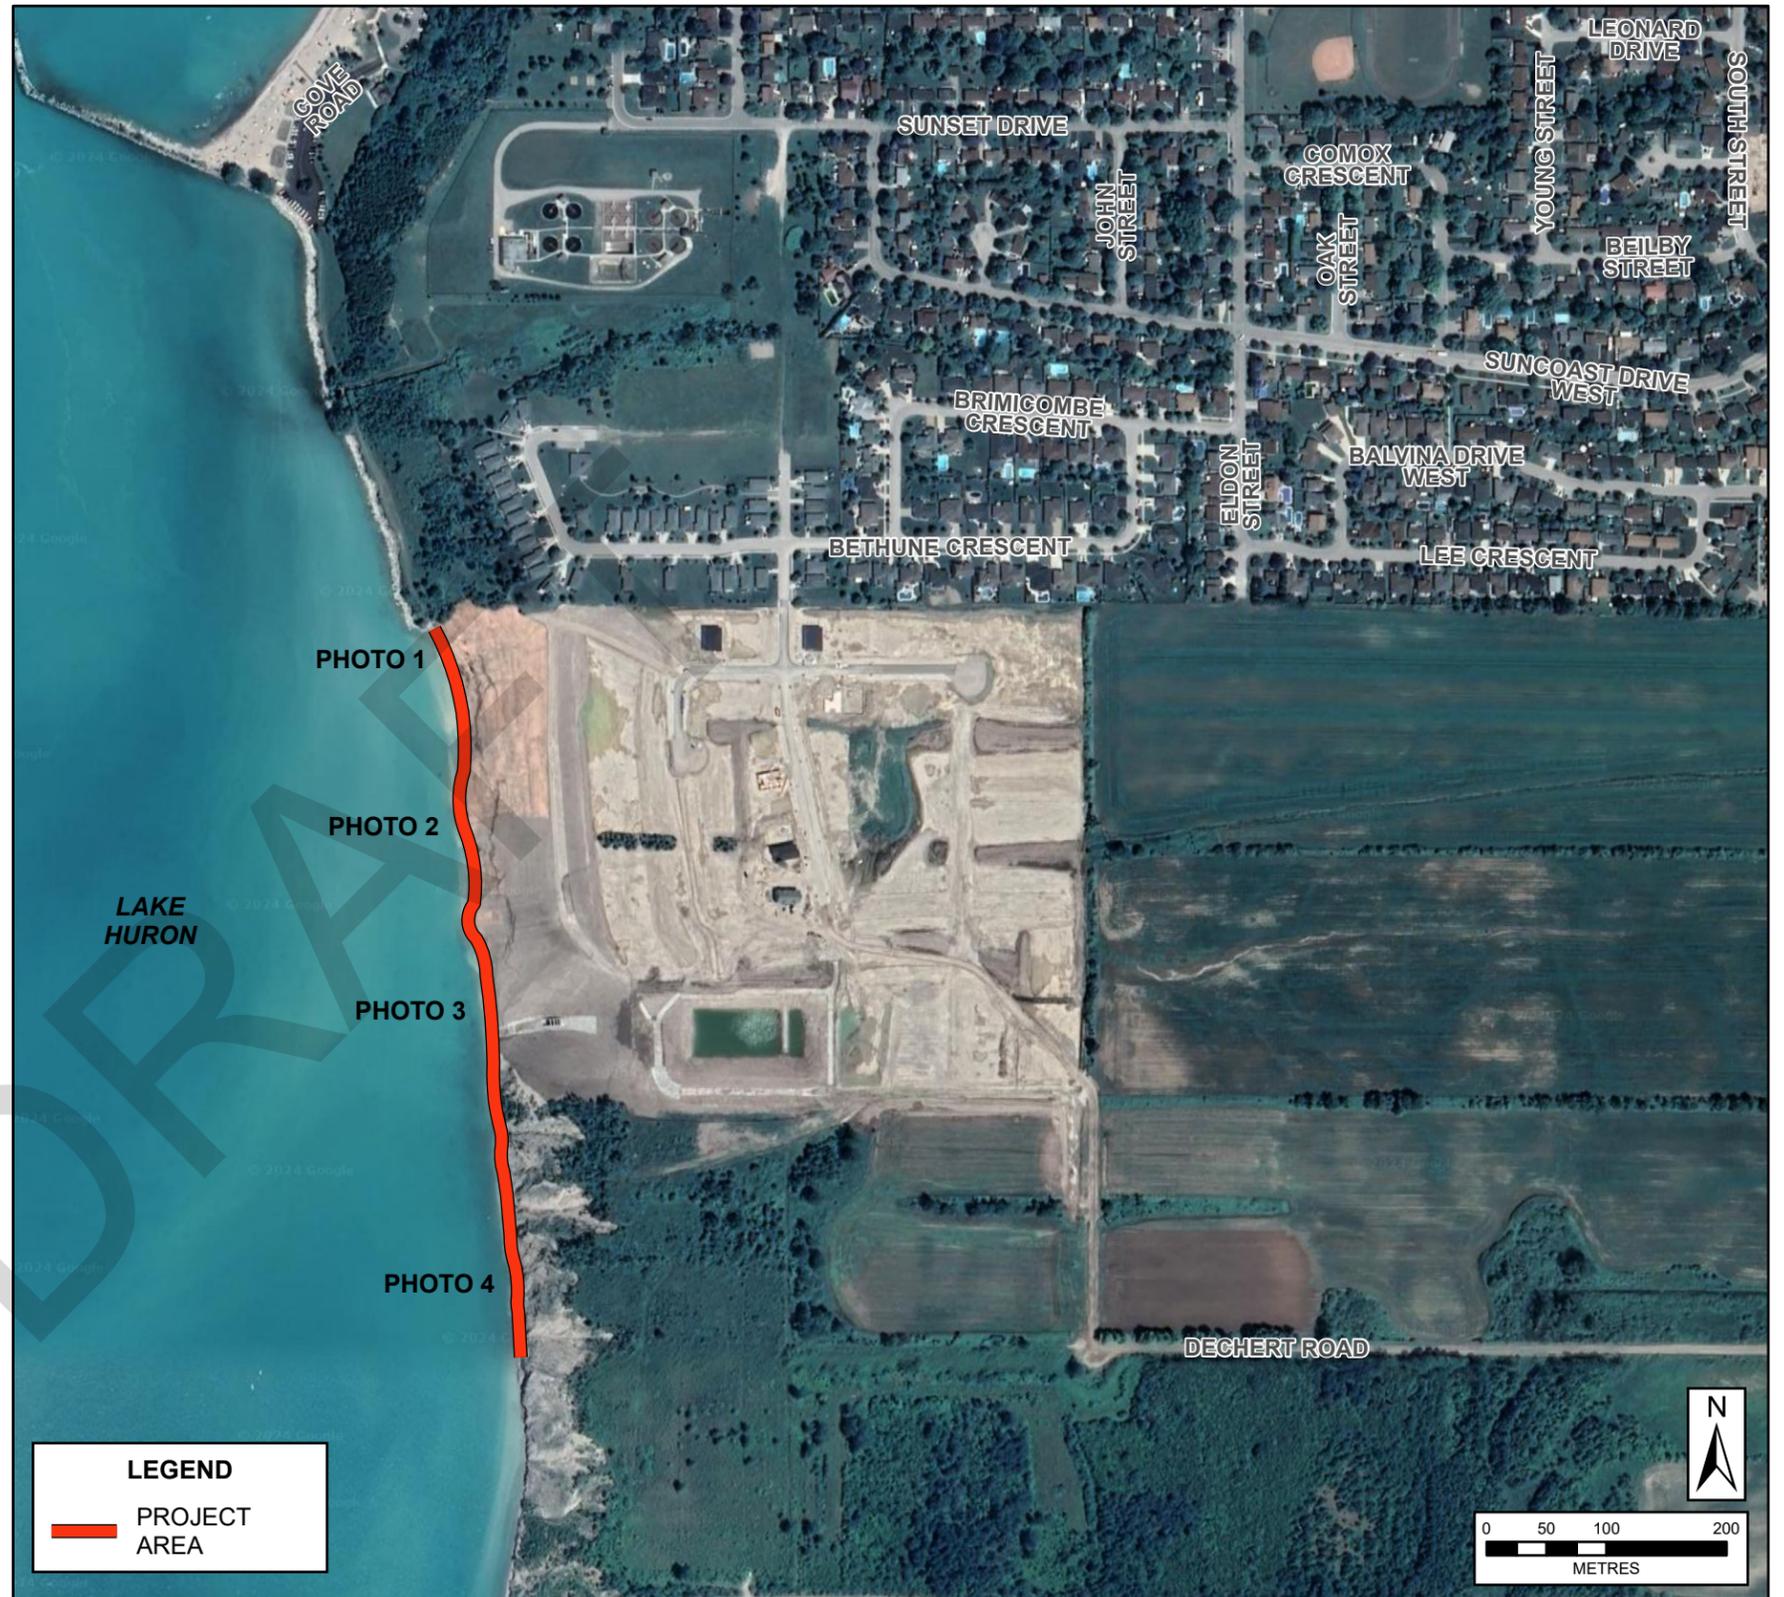
DATE DEC. 15, 2022	PROJECT No. 22236
SCALE AS SHOWN	FIGURE No. 1

AERIAL PHOTOGRAPHY OF PROJECT AREA

The Town of Goderich has requested that B. M. Ross (BMROSS) study the feasibility of hardening the Lake Huron shoreline west of Coast Drive. The study area is shown in Figure 1. The toe of the bluff is currently unprotected and actively eroding from wave action.

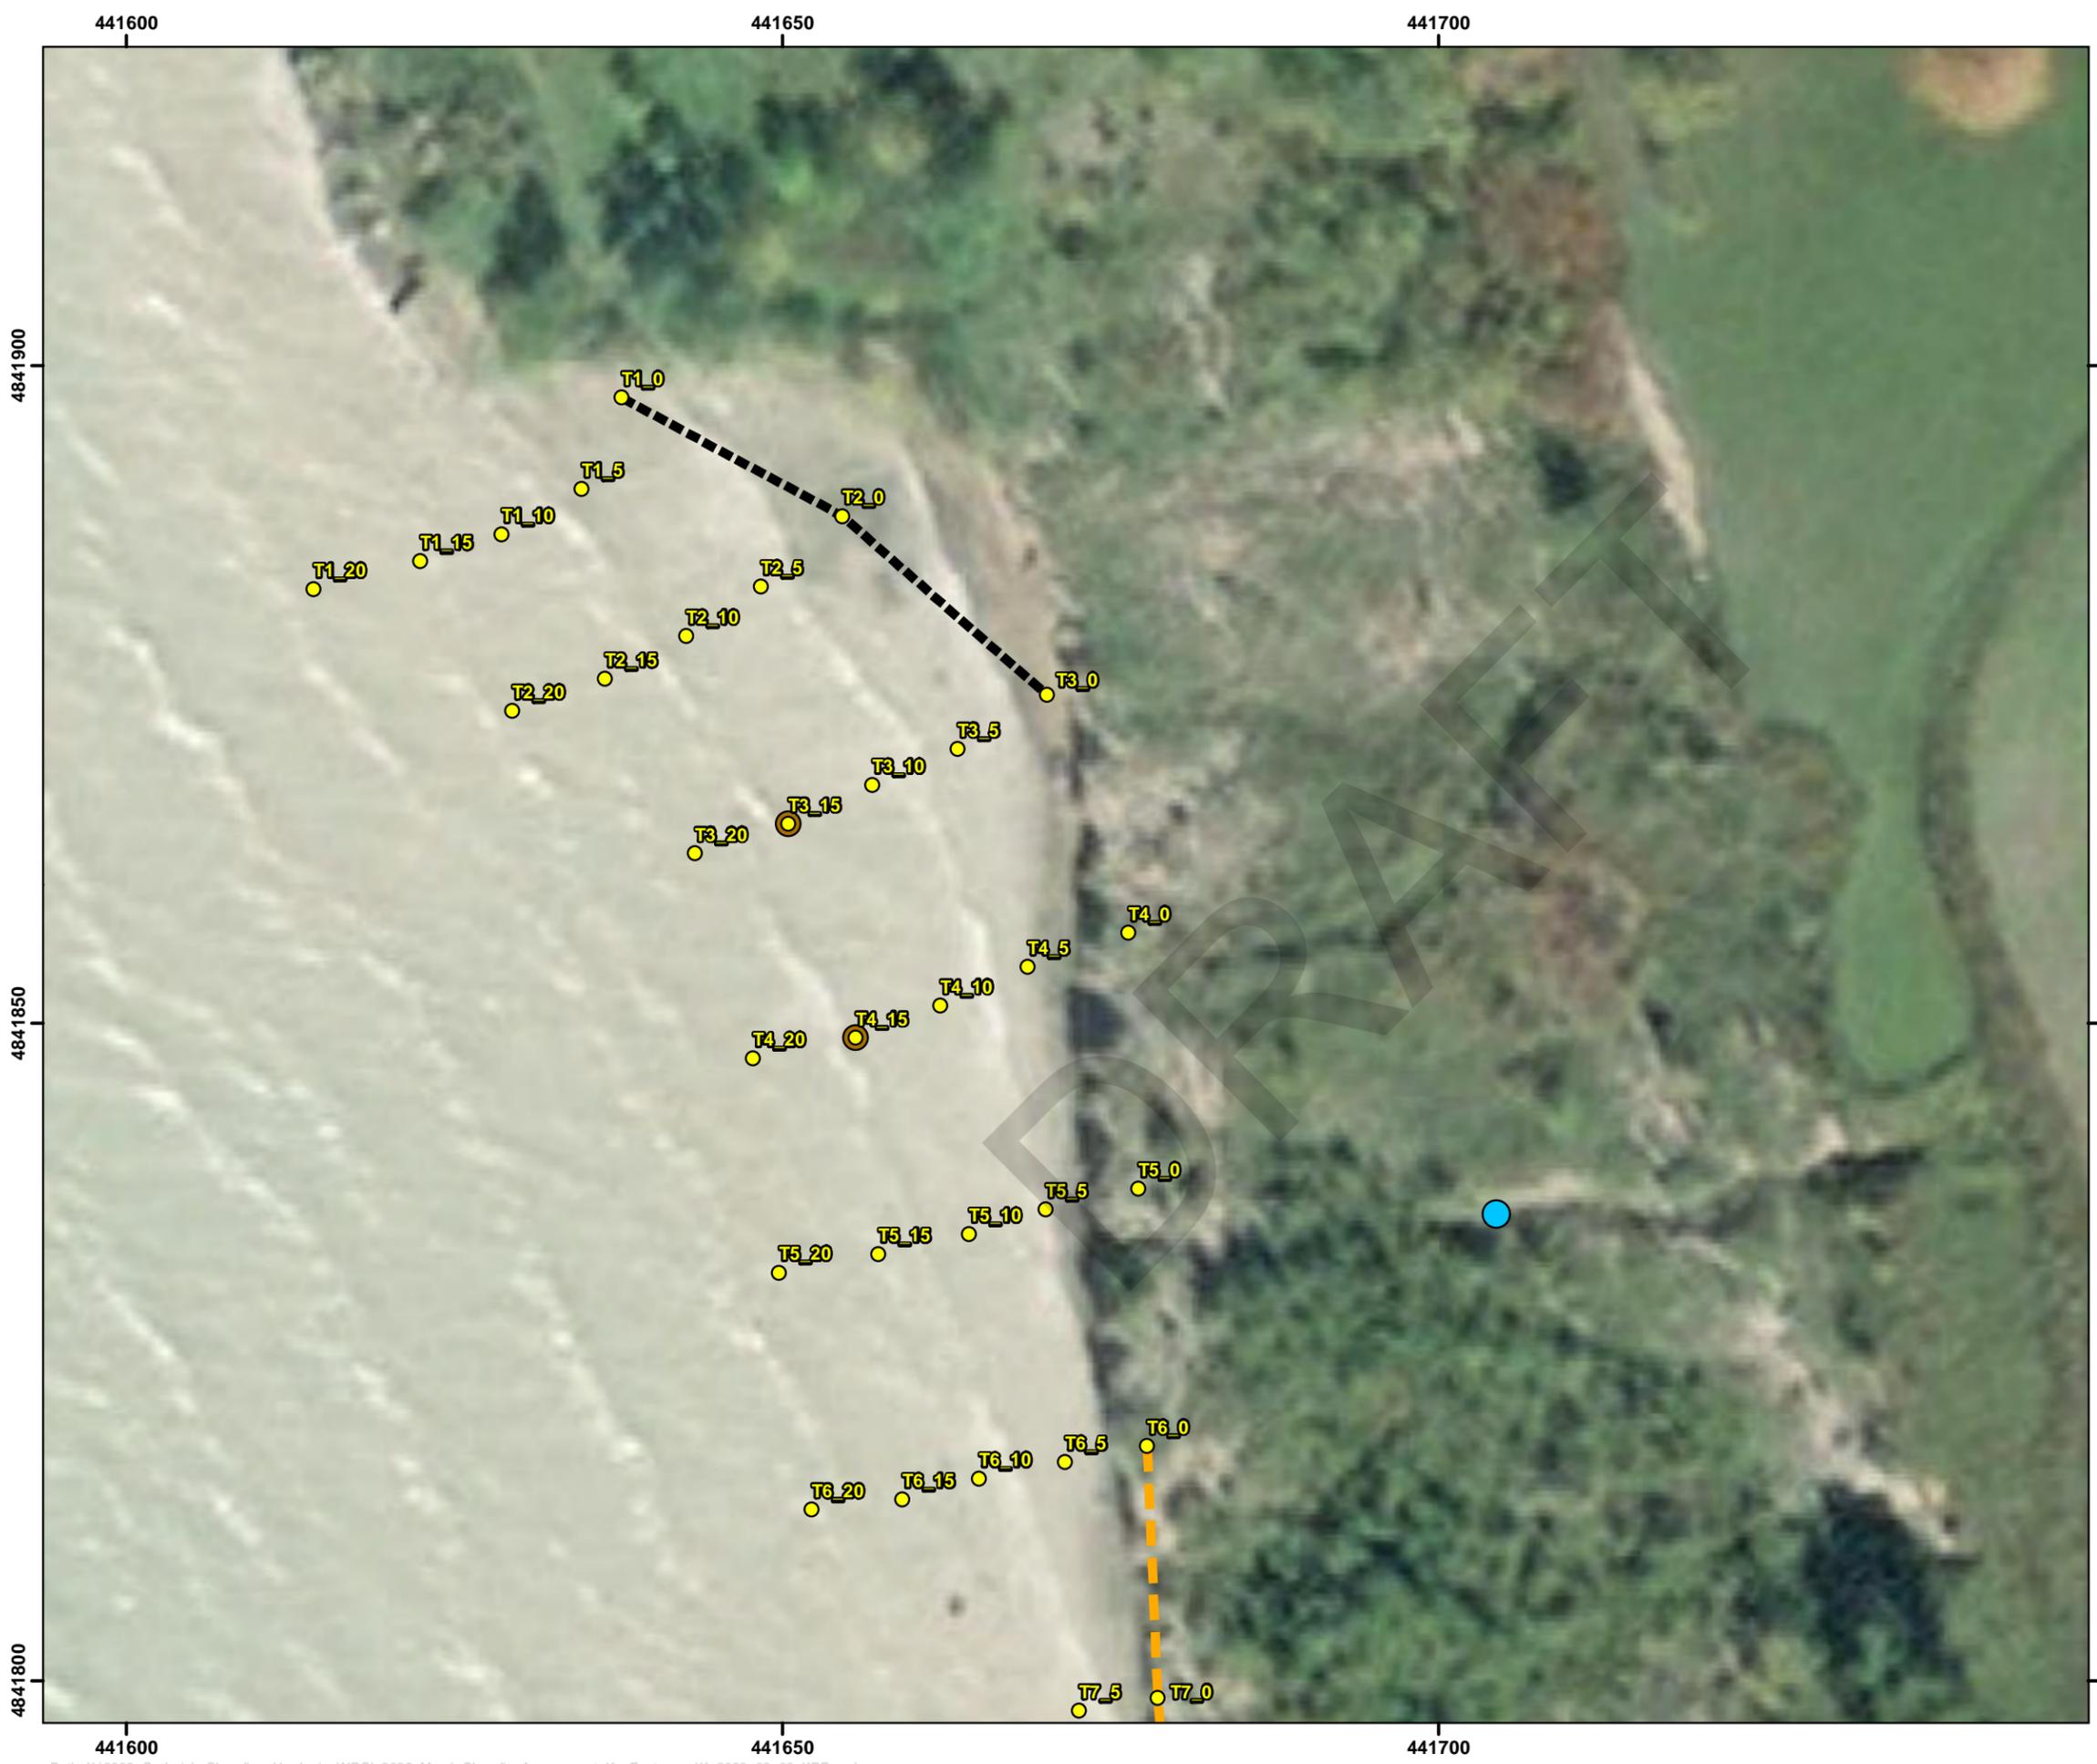
North Huron Goderich Nearshore Habitat Assessment Shoreline Assessment: Key Features

- Legend**
- Transect Point (June 20, 2023) *
 - Clay Mounds
 - Culvert
 - Broken Concrete Slabs
 - Woody Debris

mark, with the average water depth being 0.54m. Between transect 1 and transect 3, there were numerous submerged concrete slabs, which are shown on Map 1. From transect 4 to transect 17, exposed clay substrate was observed frequently. The shoreline was observed to be actively eroding through this segment, as shown through the exposed clay. Limited to no aquatic vegetation was observed within this area, with limited algae being present as well. Due to the wave action and limited water depth, habitat for fish would be generally limited, aside from a few features.

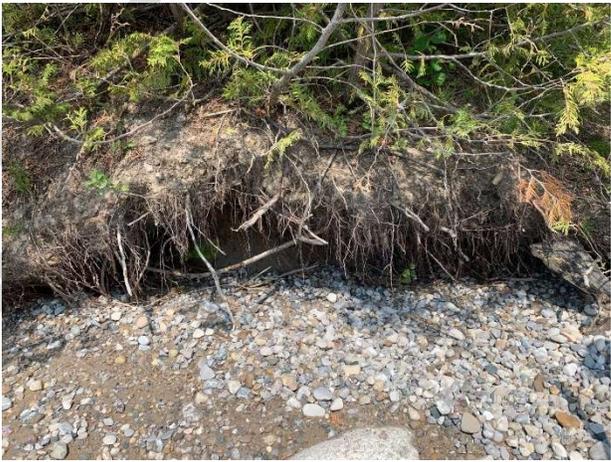
Photo 41: Undercut bank (0.46m deep) at Transect 23
